**Draft Technical Project Planning
Memorandum
Fort Flagler Military Reservation
FUDS ID F10WA0316**

**Site Inspections at Multiple Sites, NWO Region
Formerly Used Defense Sites, Military Munitions
Response Program**

**Site Inspection
Fort Flagler Military Reservation
Formerly Used Defense Site
FUDS ID F10WA0316**

Documentation for Technical Project Planning Meeting
Bureau of Land Management
Lacey, Washington
July 24, 2006

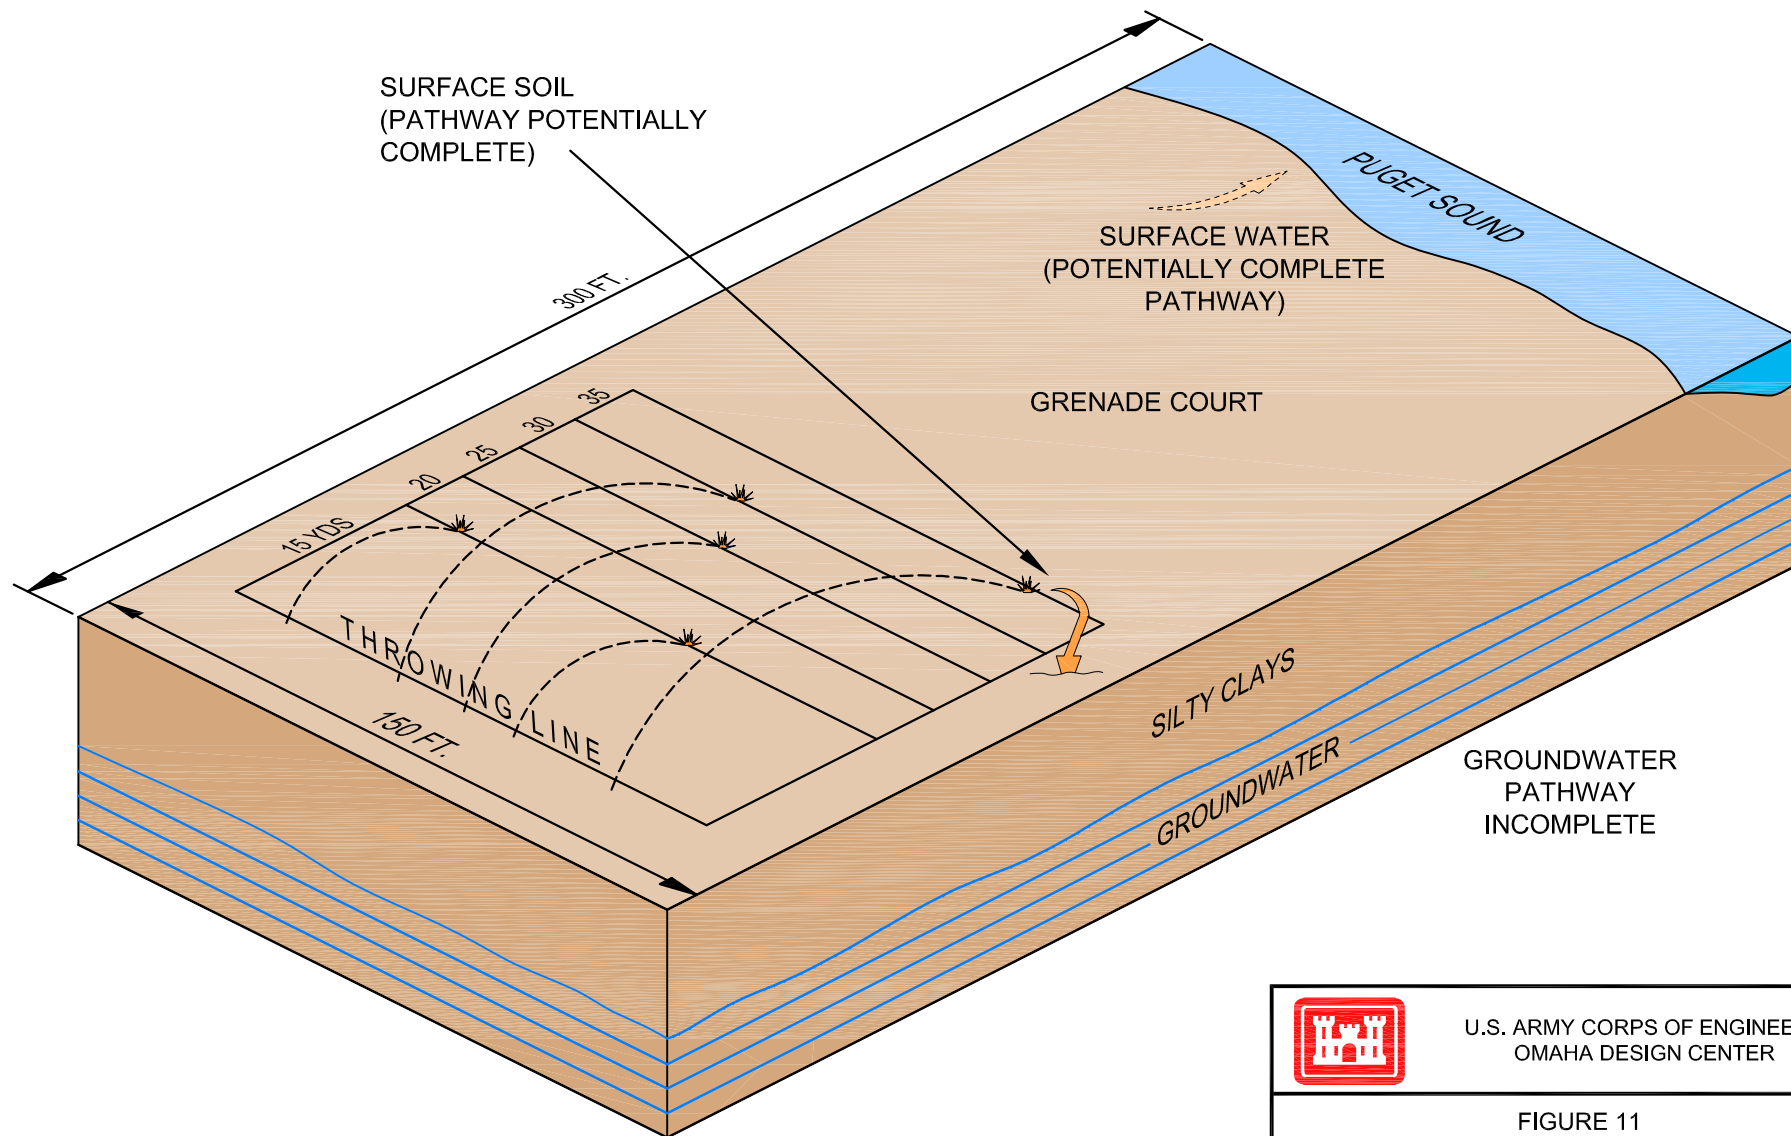
RECEPTORS:

- Recreational Site Users (Visitors)
- Site Workers (Park Personnel/Contractors)
- Biota (deer, squirrel, rabbit, etc.)

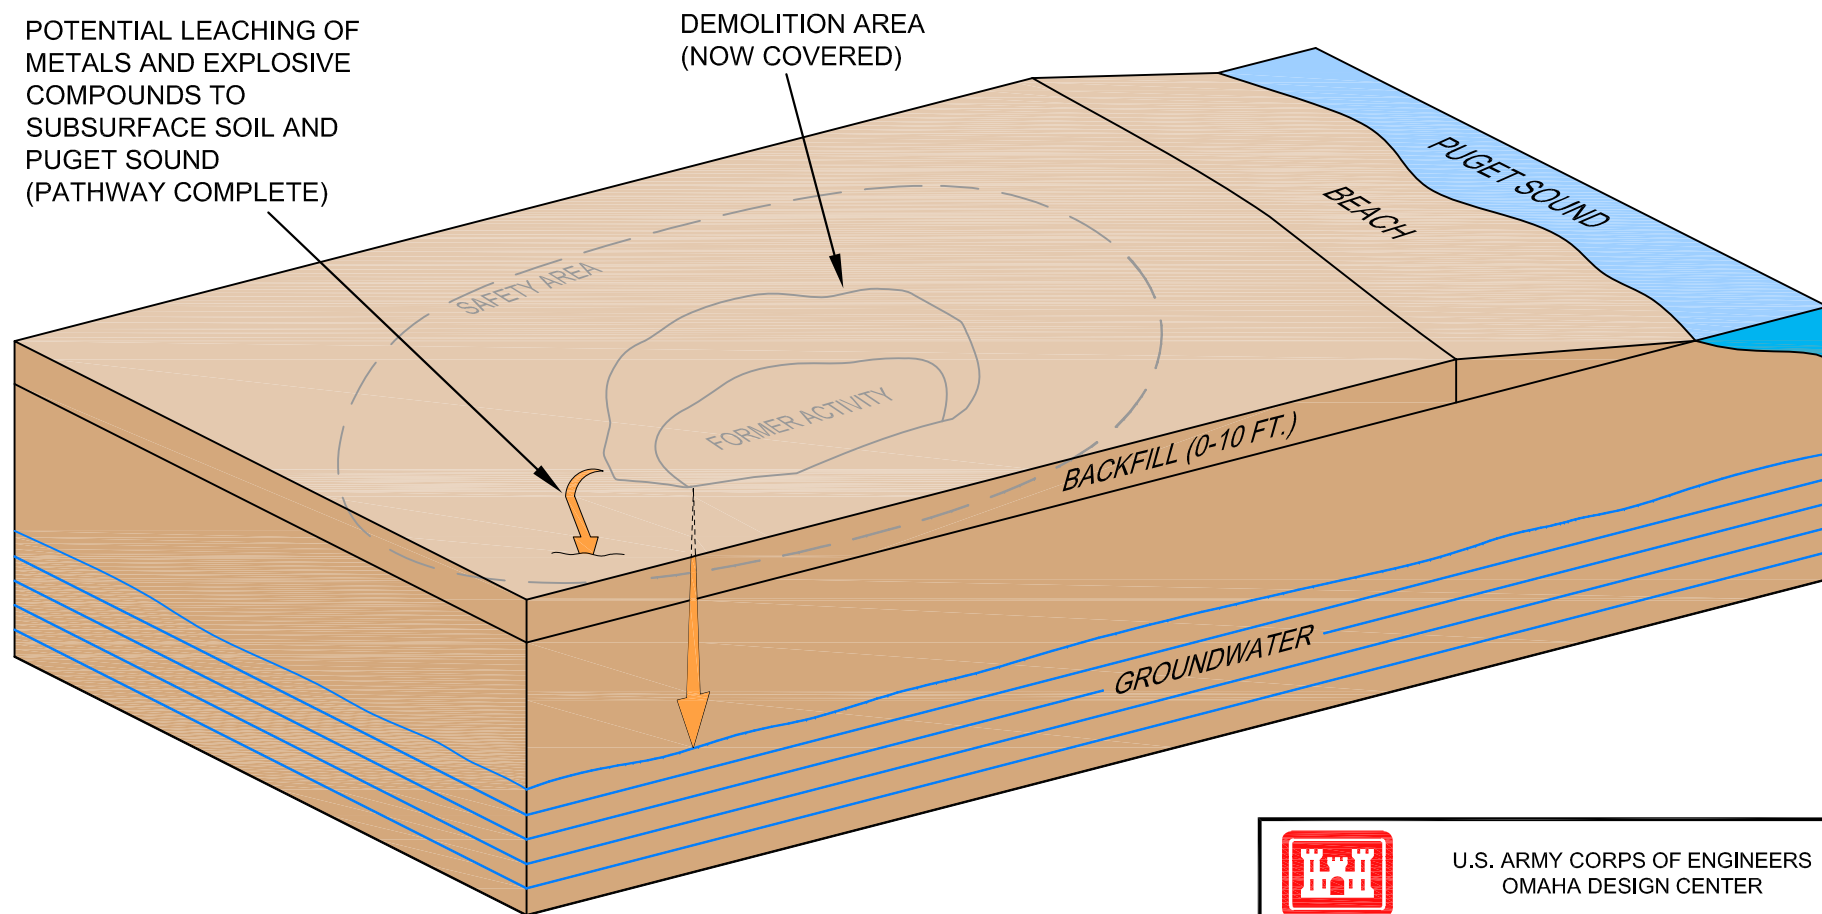
RECEPTORS:

- Park Workers Doing Excavation
- Biota (shell fish)
